RESEARCH ARTICLE

Sanitary Survey and Drinking Water Quality Performance of Treatment Plant: The Case of Dilla Town, Ethiopia.

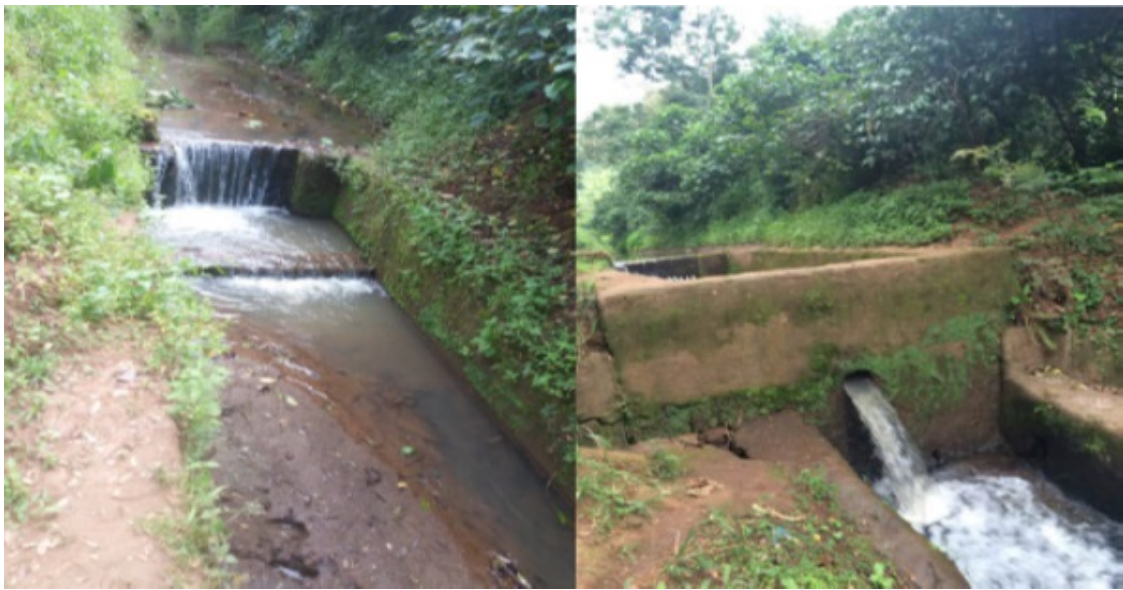
As shown in figure 1, the aeration unit in Dilla town water treatment plant has only two cascades with a step height and step length and step width of 0.65 m, 1.4 m and 0.78 m respectively. The aeration process also comes before the screening chamber which can affect the efficiency of the aeration process. A result in a study [22] indicates that the increment in dimensions of tread leads to good aeration improvement in all kinds of flow rates. Even the same trend was found in both qualities of water. Comparatively better aeration efficiency is found out with 0.6 m tread length than the water treated with lesser treads. The range of average aera-

tion efficiencies for different the ratio of tread and height(t/h) combination varies from 0.28 to 0.34 and 0.30 to 0.40 for Potable water with chemical and Potable water without chemicals respectively.

Figure 1 Dilla Town Water Treatment Plant Aeration System

Moulick *et al.*, 2010 [23] conducted experimental study on aeration performance of a rectangular stepped channel system with a height of 3.00 m. The study provides that 90 % of aeration is achievable if cascade system consists of 14 steps for a hydraulic loading $0.009 \text{ m}^3/\text{s}/\text{m}^2$ with a slope of 0.35118. However, Dilla town water treatment plant aeration has only two steps which are lower than the recommended number for cascade aerator to function properly.

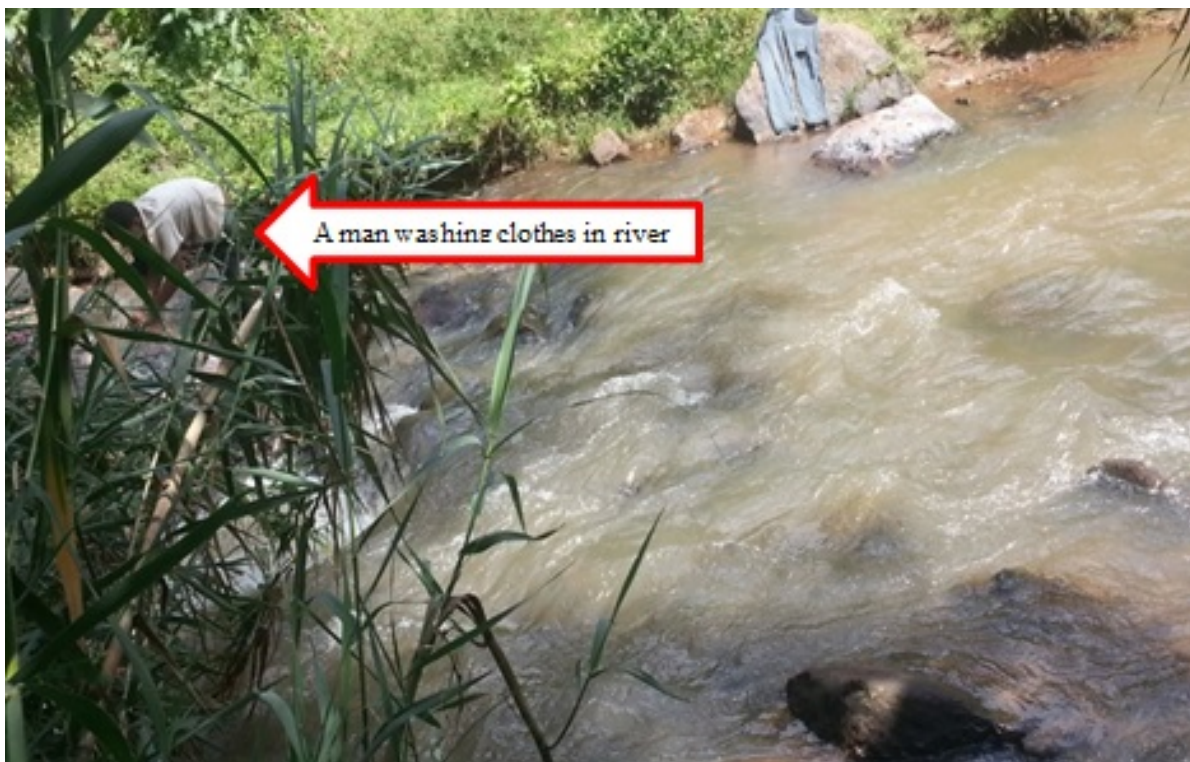
Dilla town's water treatment plant located across Laga Dara River and surrounded by residents

of Gedeo and Sidama zone as shown in figure 2. There is an ongoing pollution risk from the community since the river in upstream is being used for different human activities such as bathing and other purposes which could be a potential source for pollution by human excreta, urine, animal and domestic wastes, soaps and detergents, pesticides and fertilizers. This could be potential sources for microbial contaminations. The greater risk of contamination is most likely to be with microbiological pathogens from human and animal excreta. The activities of upstream users of the river water would affect the quality of the water for downstream users and the existing treatment efficiencies. Because the treatment may not be targeted to all types of pollutants except for common ones.

Figure 2 Human Activities in the Upper Stream of Laga Dara River, Dilla Town

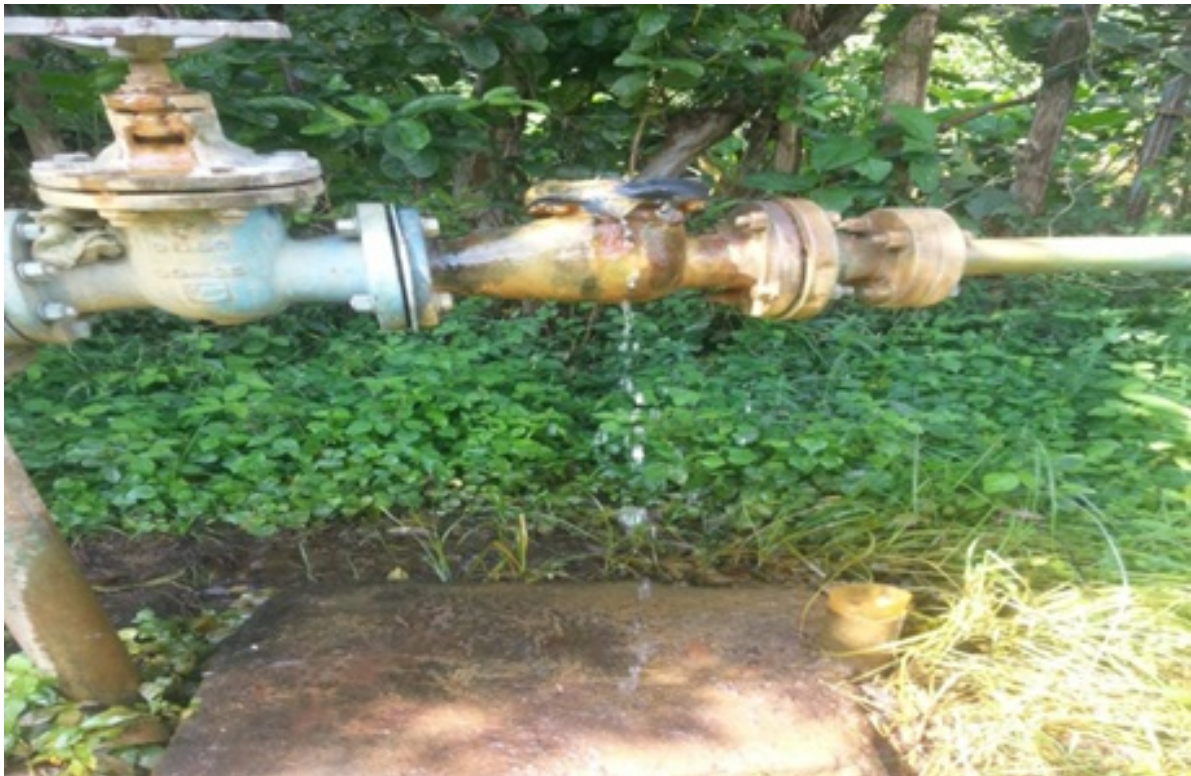
operating procedures, construction standards, and distribution system water quality data. It was observed that almost all bore holes have a common problem (Figure 3); the misuse of water, through high leakages. Some were outdated; due to this they had been giving a very low volume of water discharge.

Figure 3 Typical Borehole as Water Source of Dilla Town
